AFFIDAVIT OF LEN GARIS

Growing Marijuana in Residential Dwellings A Report on the Hazards

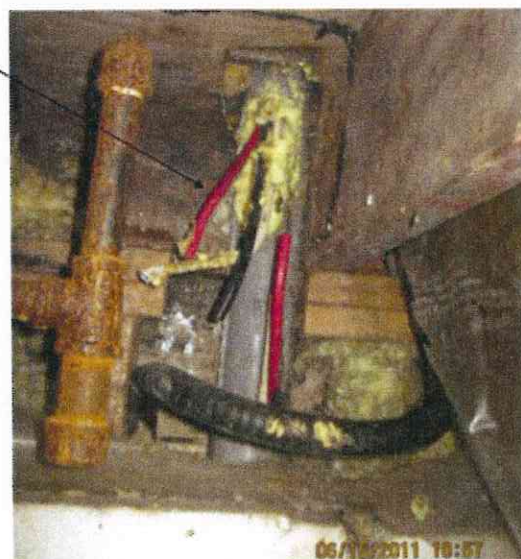
Figure 3 – High

Fire and electrocution can result from this condition, putting residents, neighbours, first responders and support crews into harmful and lethal circumstances.

Because of the extreme danger that this scenario poses around loss of property and life, immediate disconnection from the utility power grid is required.

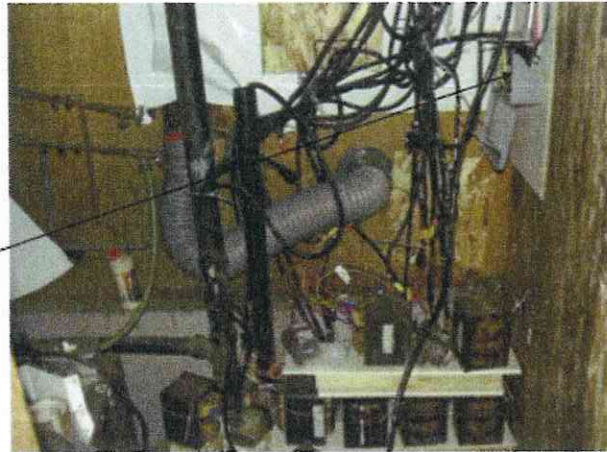
Figure 4 – High

The transformers typically step the voltage up to operate the high-powered lights. This higher voltage represents a volatile risk of electrocution to any unqualified persons.

There is no apparent guarding or protection of this apparatus from persons and property, posing a high risk to life, limb and property.

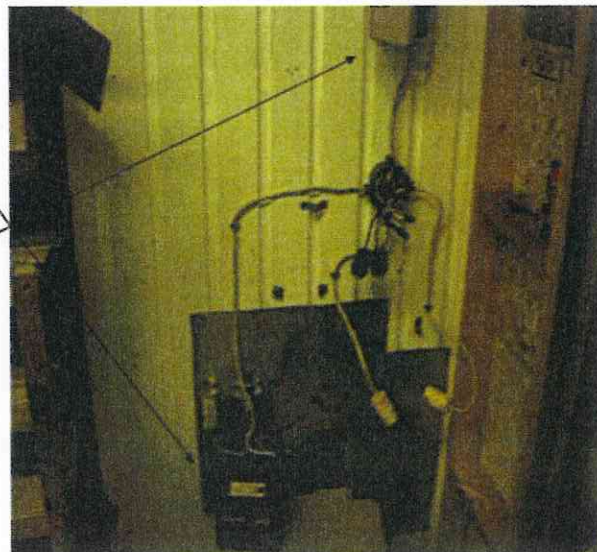
Figure 5 – Moderate

The transformers typically step the voltage up to operate the high-powered lights. This higher voltage represents a volatile risk of electrocution to any unqualified persons.

There is no apparent guarding or protection of this apparatus from persons and property, posing a high risk to life, limb and property.

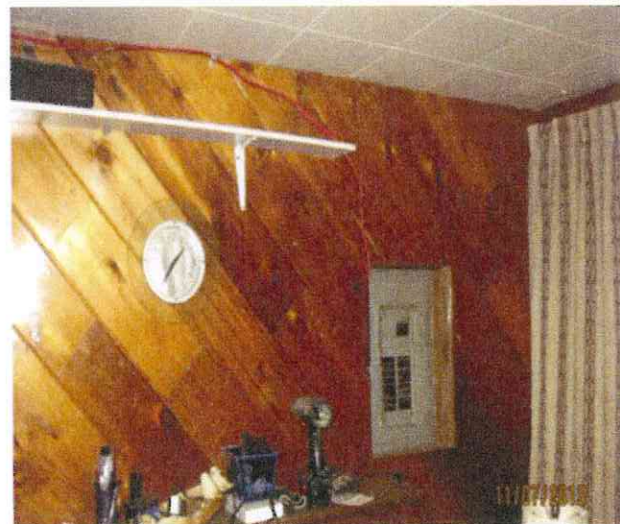
Figure 7 – Low

The risk assessment is moderate.

Electrical inspection of the residence would be required after a Certified Electrician has performed remediation of the residence's electrical system.

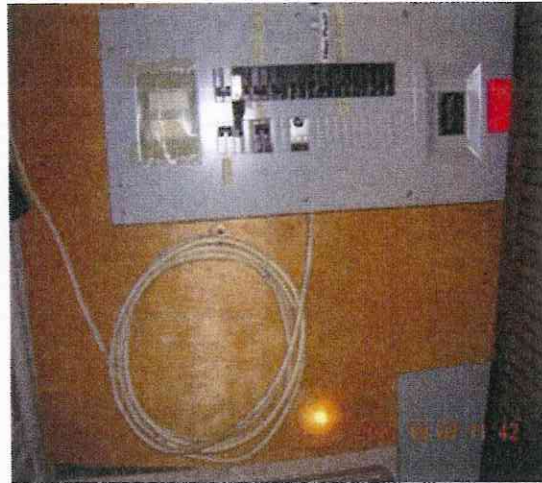
Figure 8 – Low

The risk assessment is low.

Proper support and termination will correct the deficiency.

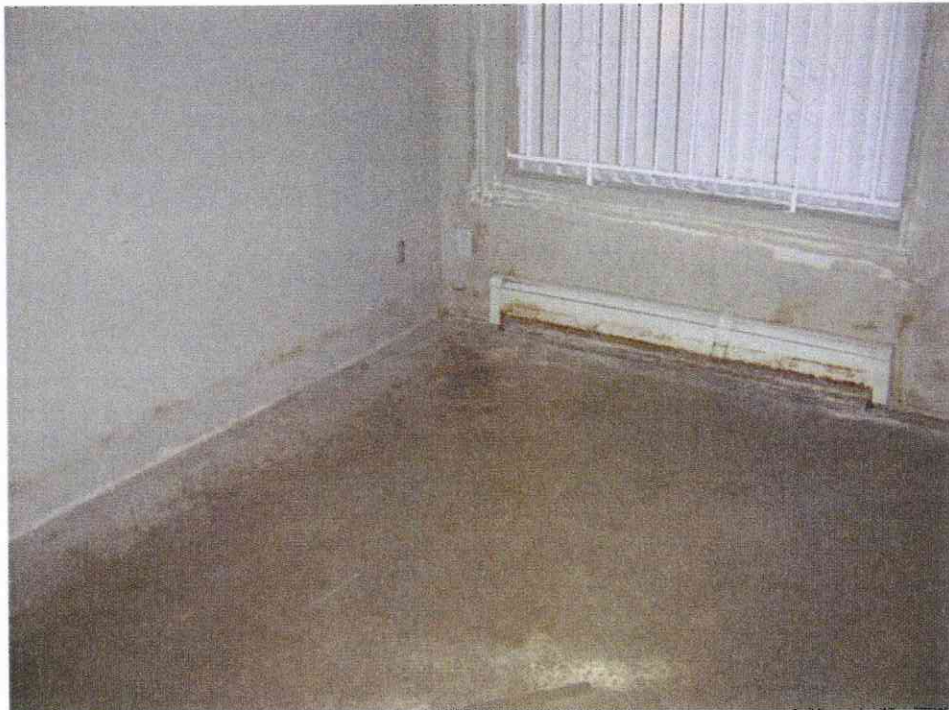
Figure 9

This is an example of what was classified as suspected mould growth.

Example of suspected mould growth (S)

This photo is an example of suspected mould growth. The base of the walls and below the window show what is presumably water staining, with fungal growth suspected at the base of the far corner and on the backside of the drywall.

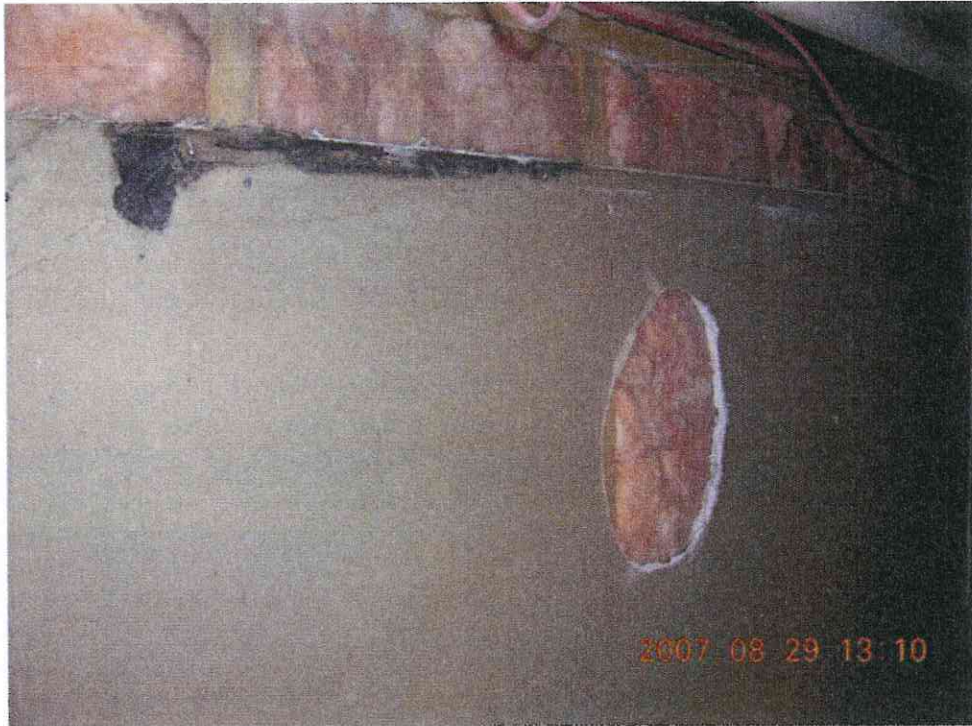
Figure 10

This figure illustrates obvious mould growth. In this instance, however, it is described as *minor* since the coverage is estimated to be less than one square meter (1 m²).

Example of minor mould growth (1)

This photo shows an example of minor mould growth (dark staining on top left corner of drywall). Minor mould growth is to be considered <math><1\text{m}^2</math>.

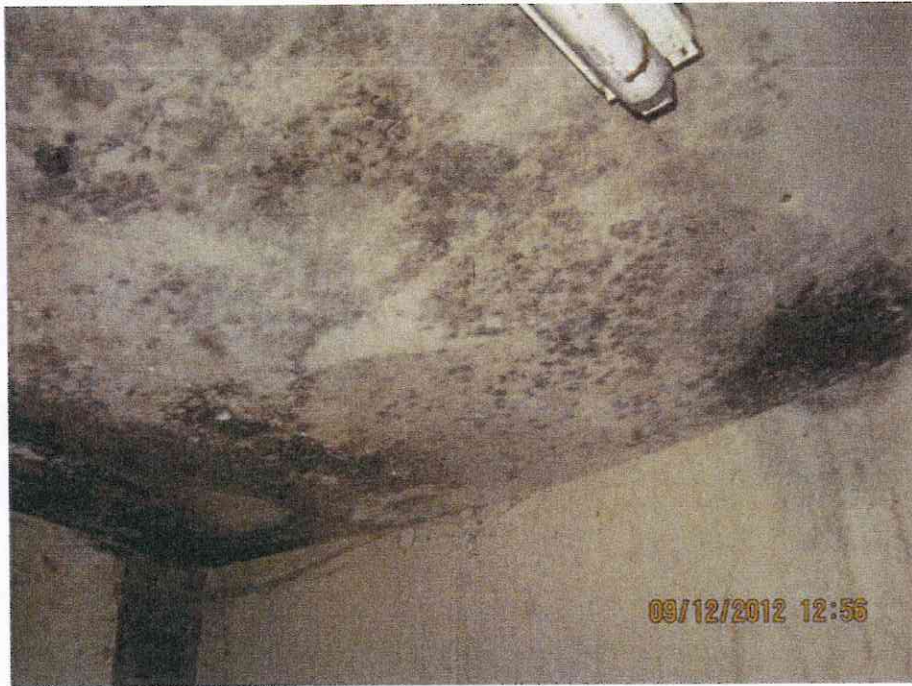
Figure 11

This is an example of major mould growth, since it is estimated to cover more than one square meter.

Example of major mould growth (2)

This photo shows an example of major mould growth (dark and spotted staining throughout drywall). Major mould growth is to be considered $>1\text{m}^2$.

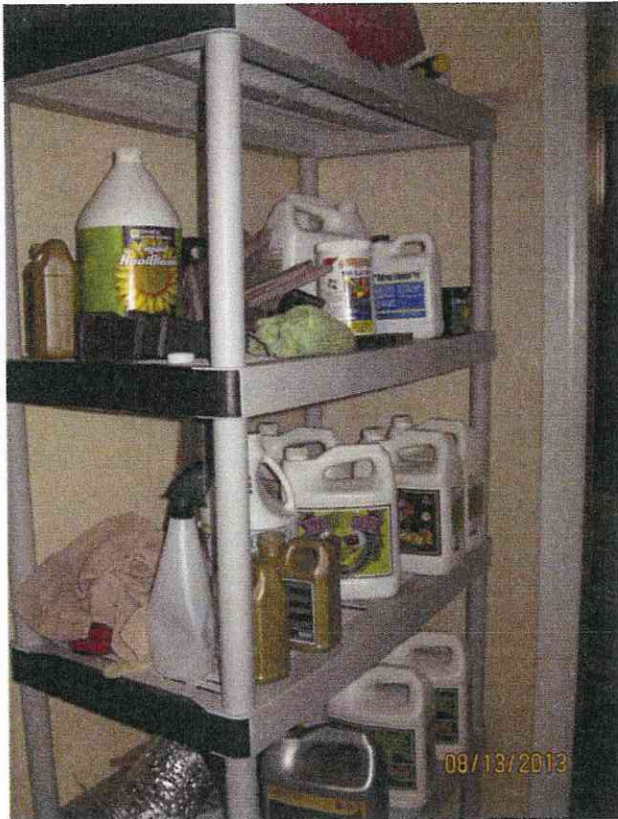
Figure 13

This figure indicates the presence of chemical containers where the labels are mostly visible. In some instances it is possible to identify what the original contents would have been; in others a determination is difficult or impossible.

Example of chemical containers—labels mostly visible

This photo is an example of stored chemical containers presumably related to the marijuana grow operation. Most containers have labels that are at least partially visible.

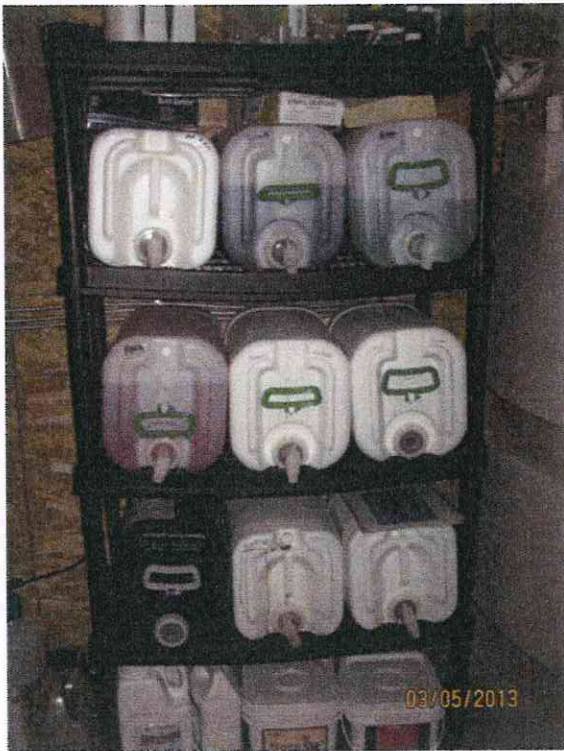
Figure 14

This figure shows containers typically manufactured to store chemicals, but the labels were either not visible or sufficiently indistinct not to be able to identify the likely contents.

Example of chemical containers—labels mostly **not** visible

This photo is an example of stored chemical containers presumably related to the marijuana grow operation. Due to the way the containers are being stored, the labels are not visible and therefore the contents cannot be identified by photos alone.

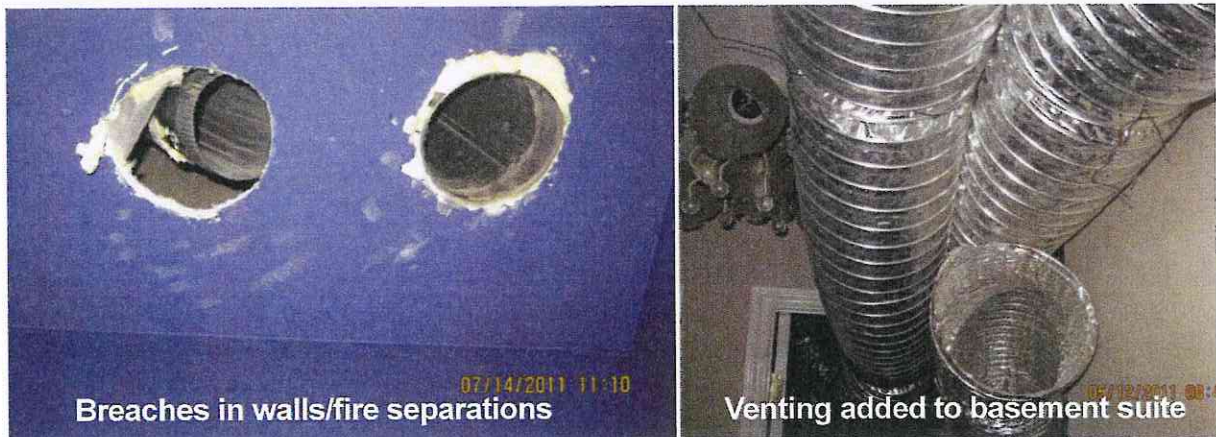
Examples of unsafe building modifications found in MGOs.

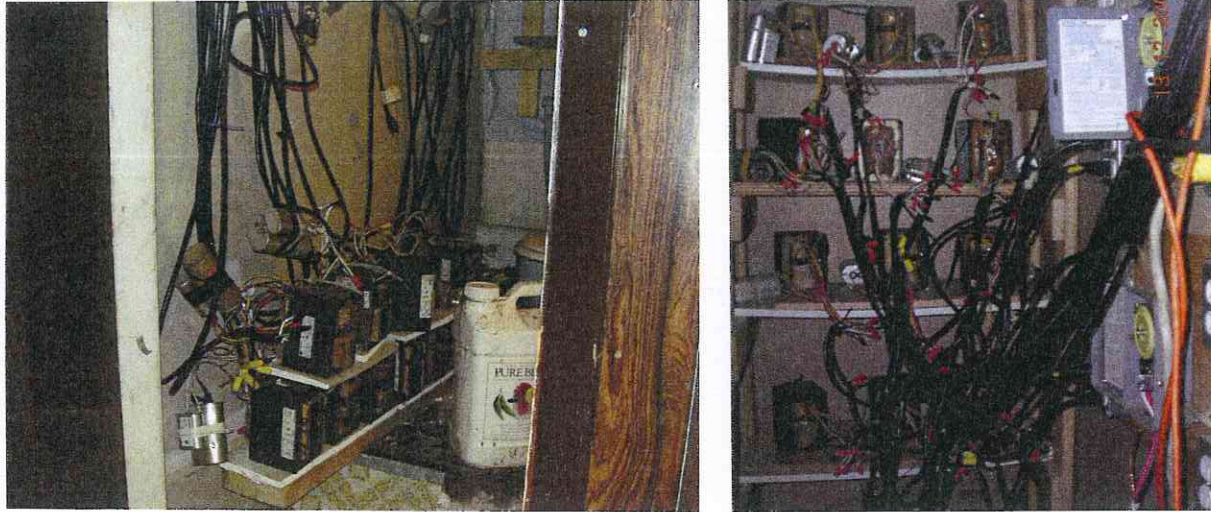
Examples of electrical issues found in MGOs with children.

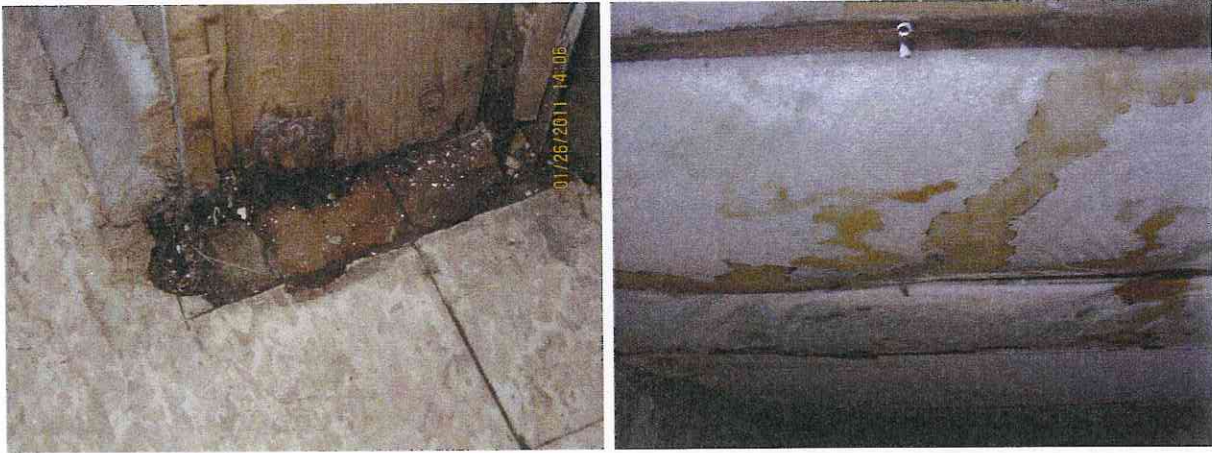
Examples of biological issues found in MGOs with children.

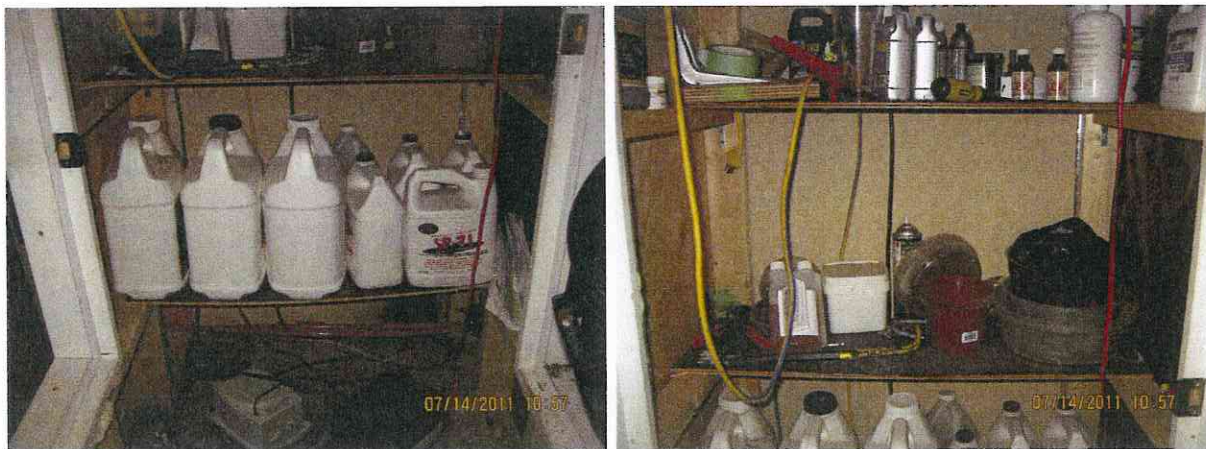
Examples of chemicals found in MGOs with children.

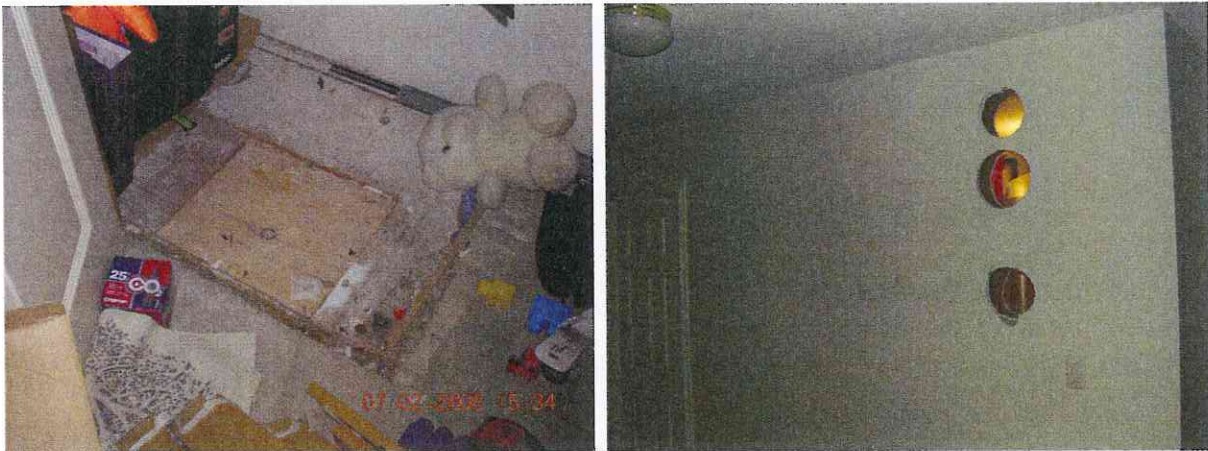
Examples of structural issues found in MGOs with children.

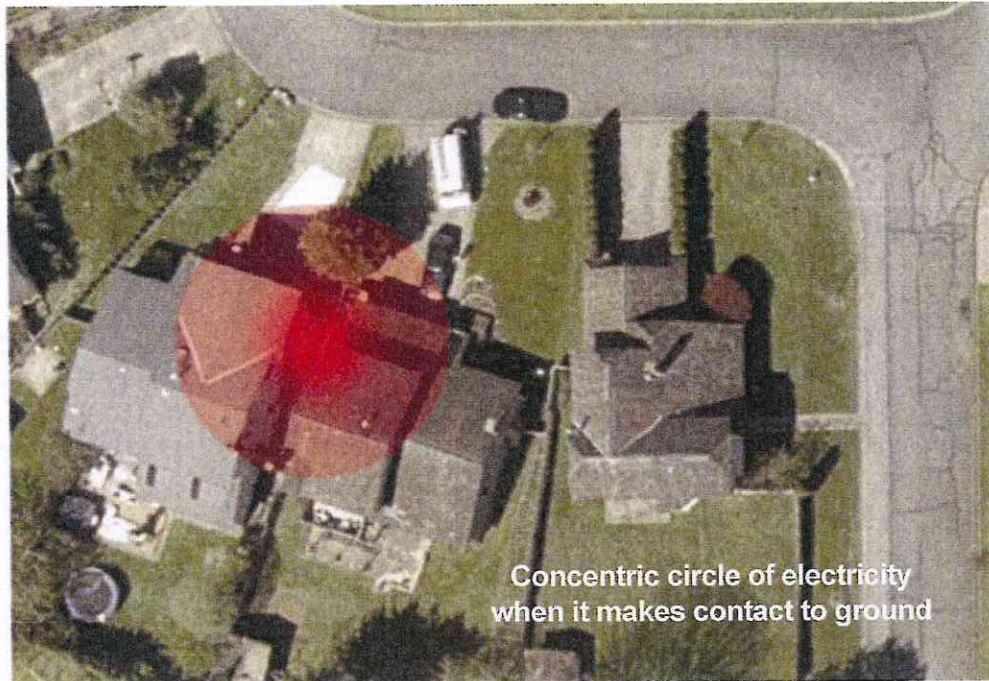
Concentric circle of electricity
when it makes contact to ground
